GEOHYDROLOGY AND WATER SUPPLY, SHEMYA ISLAND, ALASKA

By A. J. Feulner, Chester Zenone, and K. M. Reed

REVIEW OF WATER-SUPPLY DEVELOPMENT

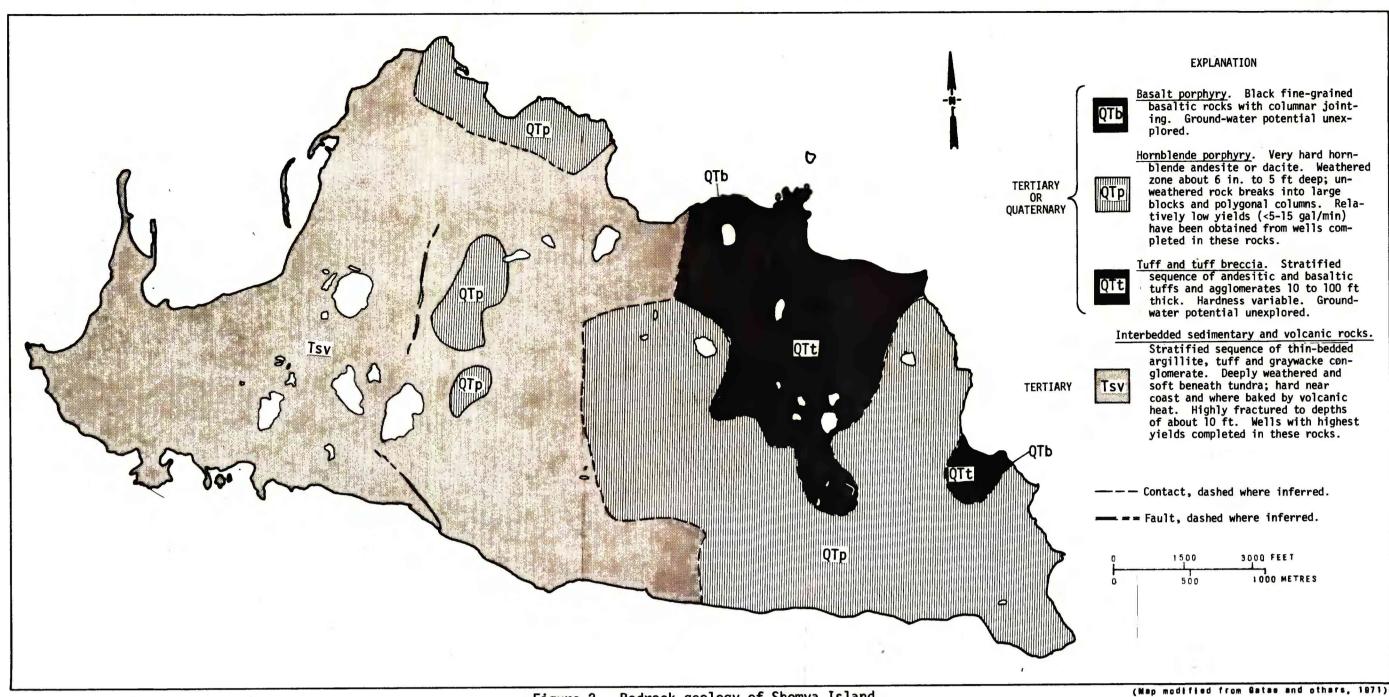
Figure 2.--Bedrock geology of Shemya Island.

Shemya Island is composed of volcanic, pyroclastic, and minor amounts of intrusive rocks. The oldest rocks are interbedded sedimentary and Volcanic rocks of Tertiary age which make up the western two-thirds of the island (fig. 2). Interbedded pyroclastic rocks, which have been intruded by small igneous bodies and are overlain locally by volcanic rocks, comprise the bulk of the eastern third of the island. Pleistocene glacial deposits, consisting of ground moraine and outwash sand, gravel, and boulders, are present in the east-central part of the island (fig. 3). The average thickness of these deposits is 5 feet, but locally may be 12 or more feet thick. The youngest geologic materials are the sand, gravel, and boulder deposits on modern and old raised beaches peat deposits which range in thickness from a few inches to as much as 15 feet, and colian sand in still-active dunes on the southern coastal portion of the island. Peat deposits are the predominant surficial deposit on the island. The geologic history and rock types occurring on Shemya Island are described in detail by Gates and others (1971).

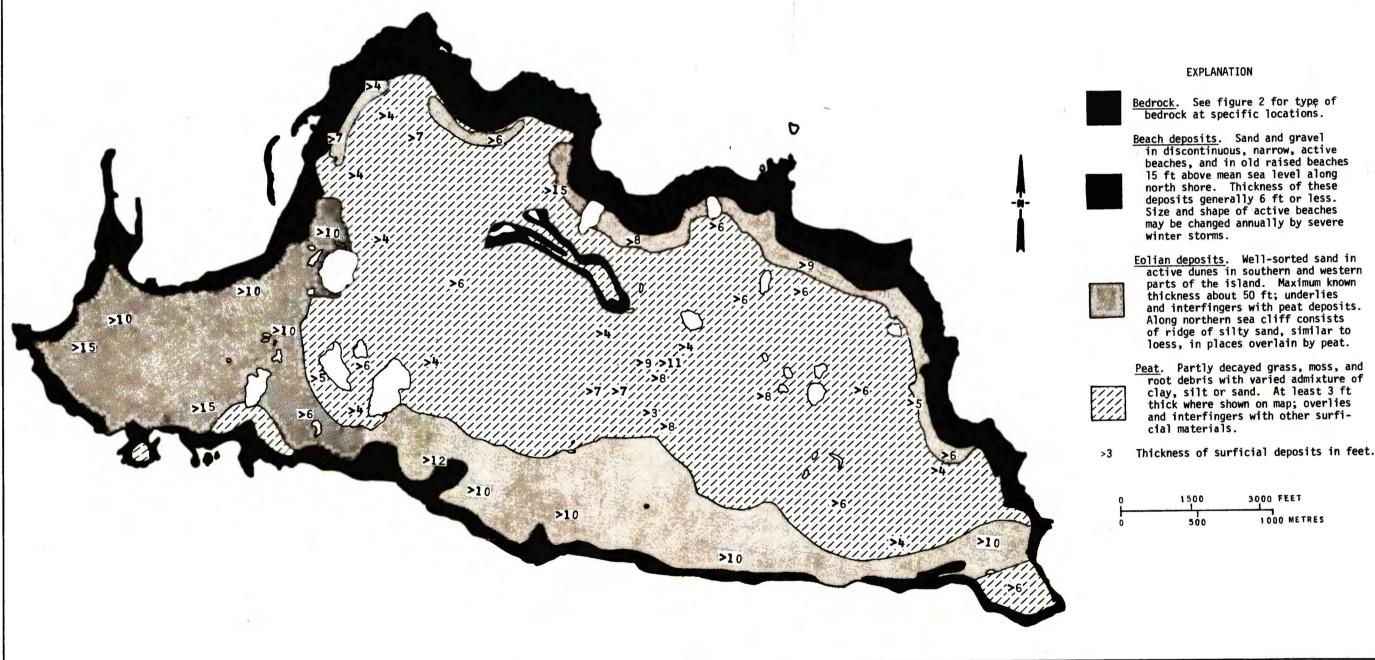
Figure 3.--Surficial deposits of Shemya Island.

(Map modified from U.S. Gaological Survey, 1980).

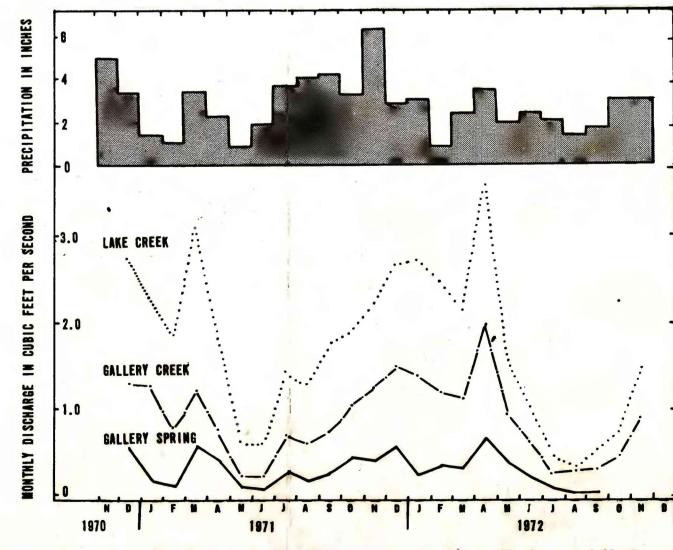
Figure 4. -- Precipitation data from a gage near the south shore and discharge measurements from gaging stations, Shemya Island.
